1 REPORT NO FHWA-CA-TL-7169-77-28		2 GOVERNMENT ACCESSION NO		3 RECIPIENT'S CATALOG NO	
4 TITLE AND SUBTITLE Design of An Air Quality Monitoring Trailer For Regional Air Quality Assessment				5 REPORT DATE December, 1977	
				6 PERFORMING ORGANIZATION CODE	
7 AUTHOR(S) Pinkerman, K.O., Sundquist, C.R., Shirley, E.C.				8 PERFORMING ORGANIZATION REPORT NO 19701-657169	
9 PERFORMING ORGANIZATION NAME AND ADDRESS Office of Transportation Laboratory California Department of Transportation Sacramento, CA 95819				10 WORK UNIT NO	
				11 CONTRACT OR GRANT NO A-8-27 19-603116	
12 SPONSORING AGENCY NAME AND ADDRESS California Department of Transportation Sacramento, California 95807				13 TYPE OF REPORT & PERIOD COVERED Interim 1975-76	
				14 SPONSORING AGENCY CODE	
15 SUPPLEMENTARY NOTES Conducted in cooperation with the U. S. Department of Transportation, Federal Highway Administration.. Study Title: Transportation Systems and Regional Air Quality

16. ABSTRACT <p>A vehicular impact test, 4700 lb (2130 kg) vehicle/61 mph (27 m/s)/26 degrees (0.46 rad), was conducted on a continuous New Jersey concrete median barrier (CMB) without a footing cast on an asphalt concrete surface. The test b

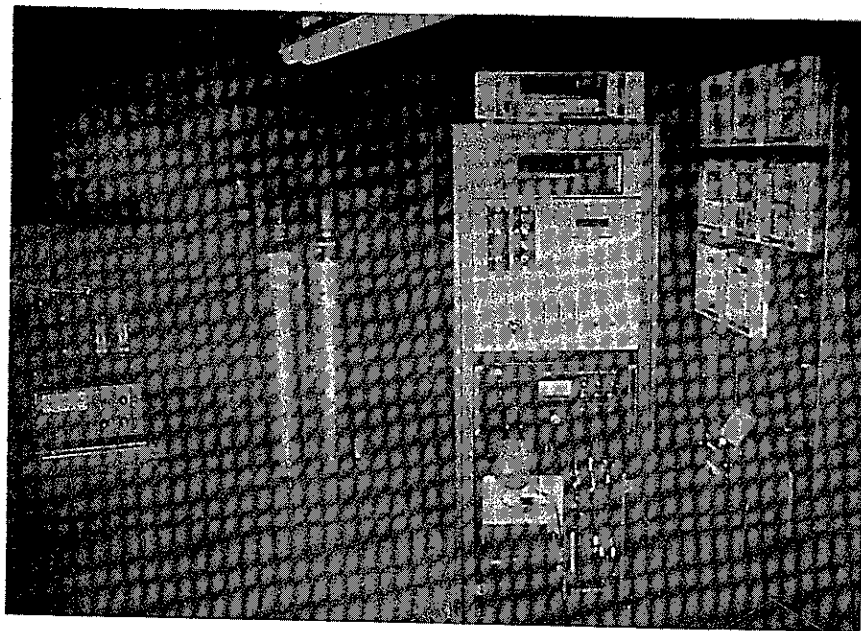
Fig. 1 Trailer interior. Rack right center holds analyzers for ozone, oxides of nitrogen, and hydrocarbons.

The interior of the trailer was modified with the addition of one 4 foot (1.22 m) base cabinet with plywood top, one Budd 70 inch (178 cm) instrument rack, cylinder anchor chains mounted to the rear wall, and a frame and panel for the recorders (see Figures 1 and 2).

The cabinet provides a surface to mount the carbon monoxide analyzer and gives storage drawers, etc. The instrument rack is fastened to the floor and to the wall studs. It is the container for the other analyzers and some support equipment for the hydrocarbon analyzer.

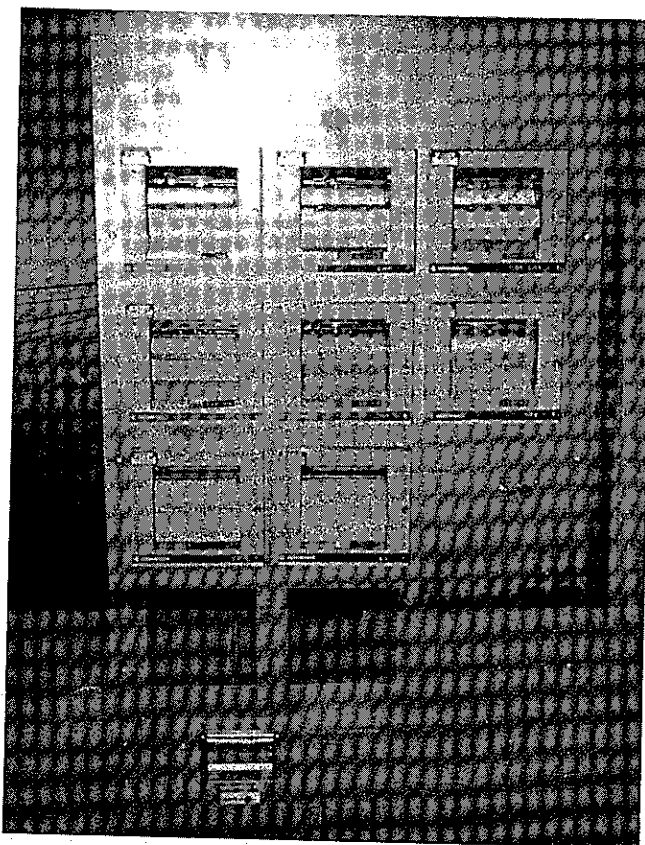
Fig. 2 Recorder package and data acquisition (Cassette Magnetic Tape)

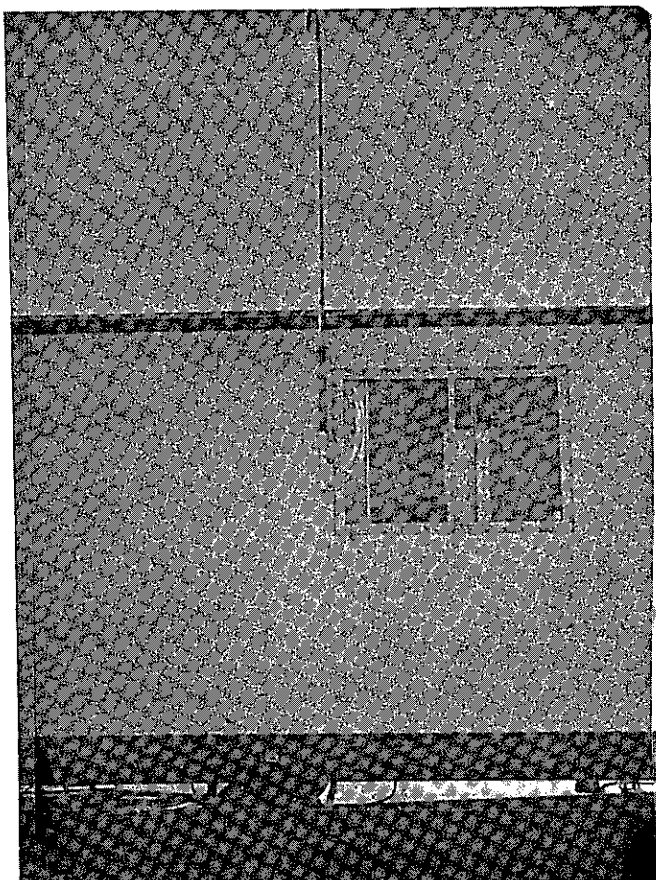
**Fig. 3 Sample Mast
with Rain Shield**

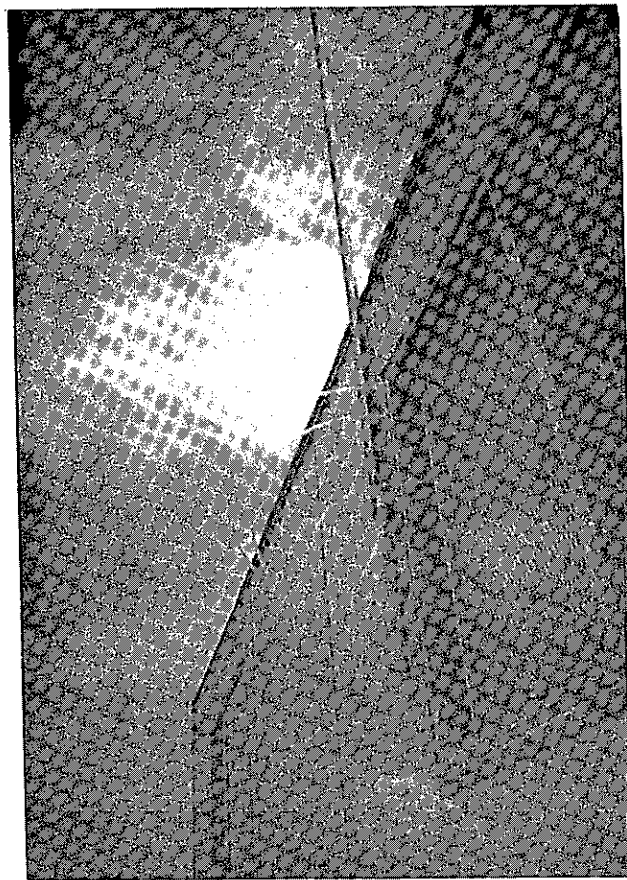
Fig. 4 Sample Lines Inlet

These trailers are a basic assembly of analyzers and support systems, and utilize the simplest sampling system possible. Each analyzer has its own 1/4" (0.64 cm) teflon sample supply line from outside the trailer. They are bundled in one piece of conduit that raises 8 feet (2.44 m) above the trailer and ends in an upside down plastic beaker (see Figure 3) for rain protection. Each line enters the wall through a stainless steel bulk head fitting and travels directly to the analyzer (see Figure 4). Therefore, the analyzer pump is the only sample supply component required.

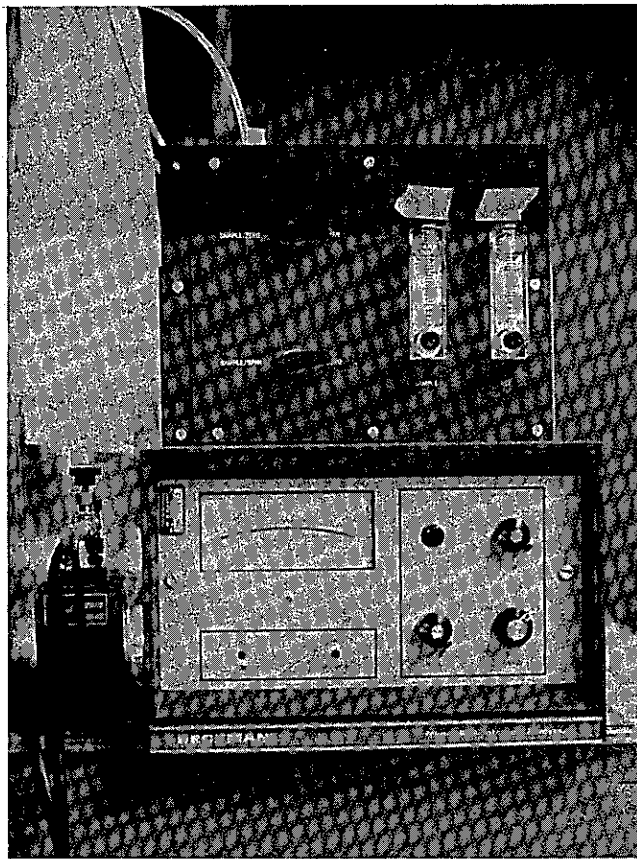
Fig. 5 Carbon Monoxide Analyzer and Sample Pump

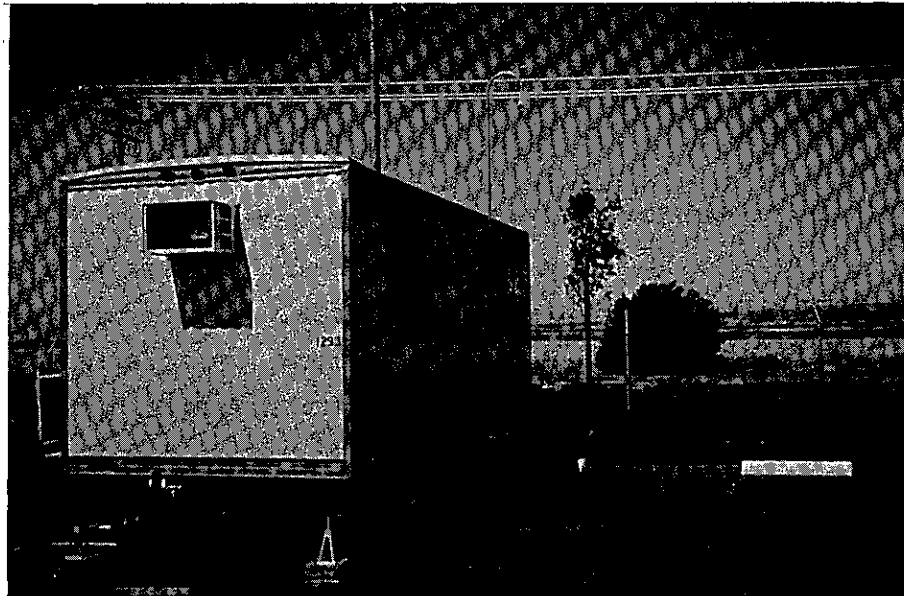
**Fig. 6. Air Monitoring Trailer
Typical Site Location**

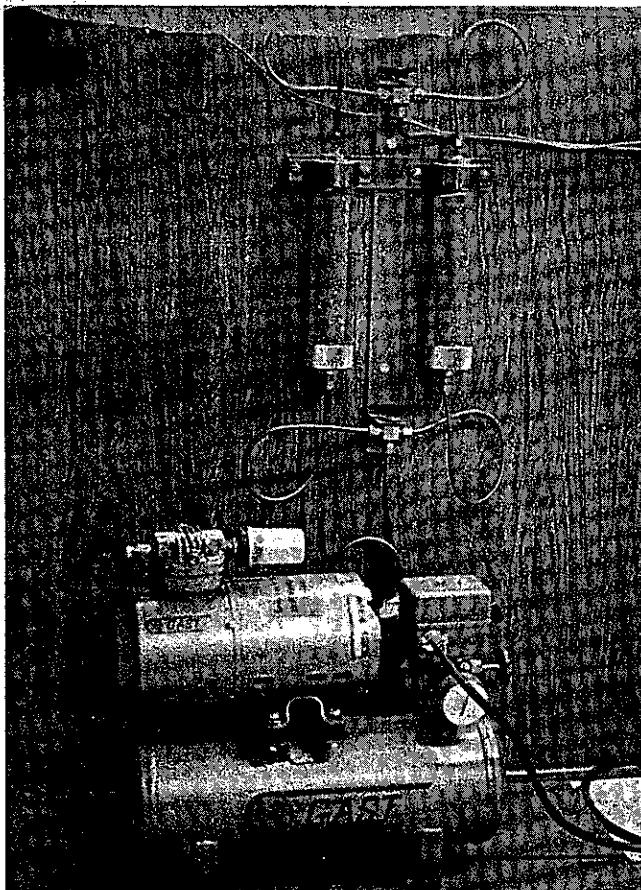
Fig. 7 Air Compressor and Drier System

This analyzer is calibrated with cylinders of span gases. Methane (4-5 ppm) in air is the gas mixture used for spanning. It is important that all support gases, carrier air, hydrogen, etc., be free of contaminants such as hydrocarbons or moisture. Therefore, all carrier air is scrubbed with a thermal catalytic device to oxidize any stray hydrocarbons to an acceptable level. In addition the air (compressor supplied) and hydrogen are dried by passing through silica gel to prevent column contamination and interferences (see Figure 7).

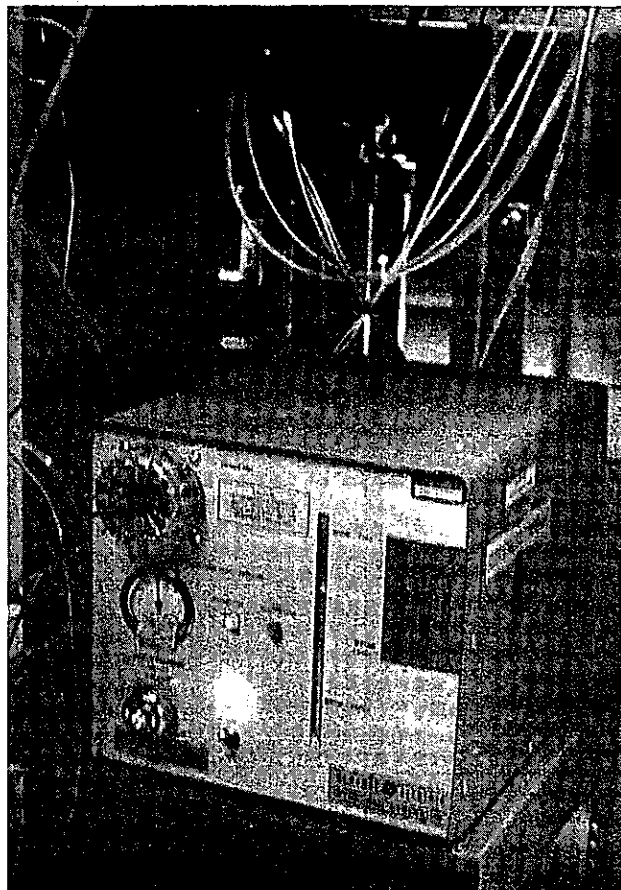
Fig. 8 Hydrogen Generator and Drier System

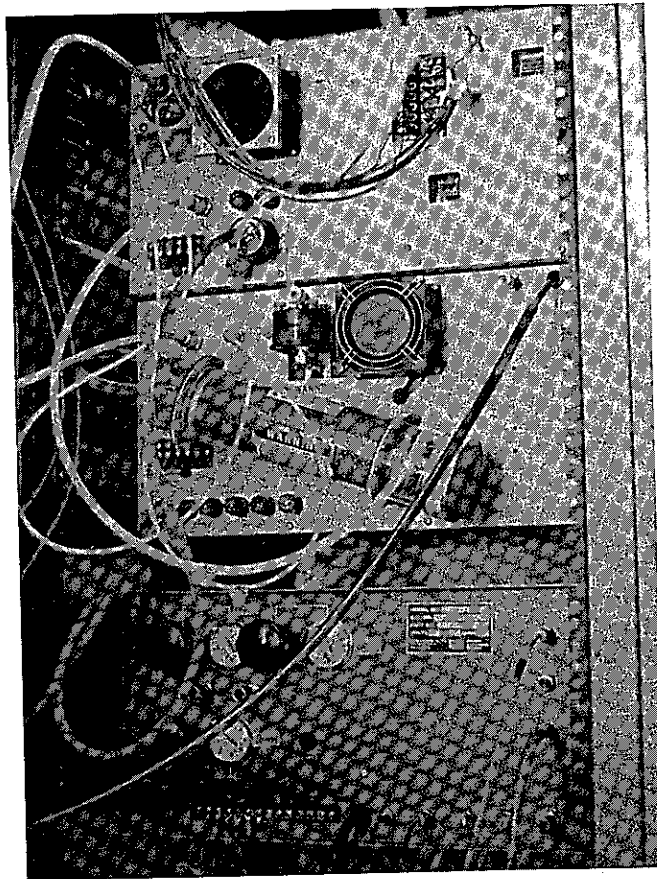
Fig. 9 Rear Support System for NO_x Analyzer
(Top Two) and THC Analyzer (Bottom)

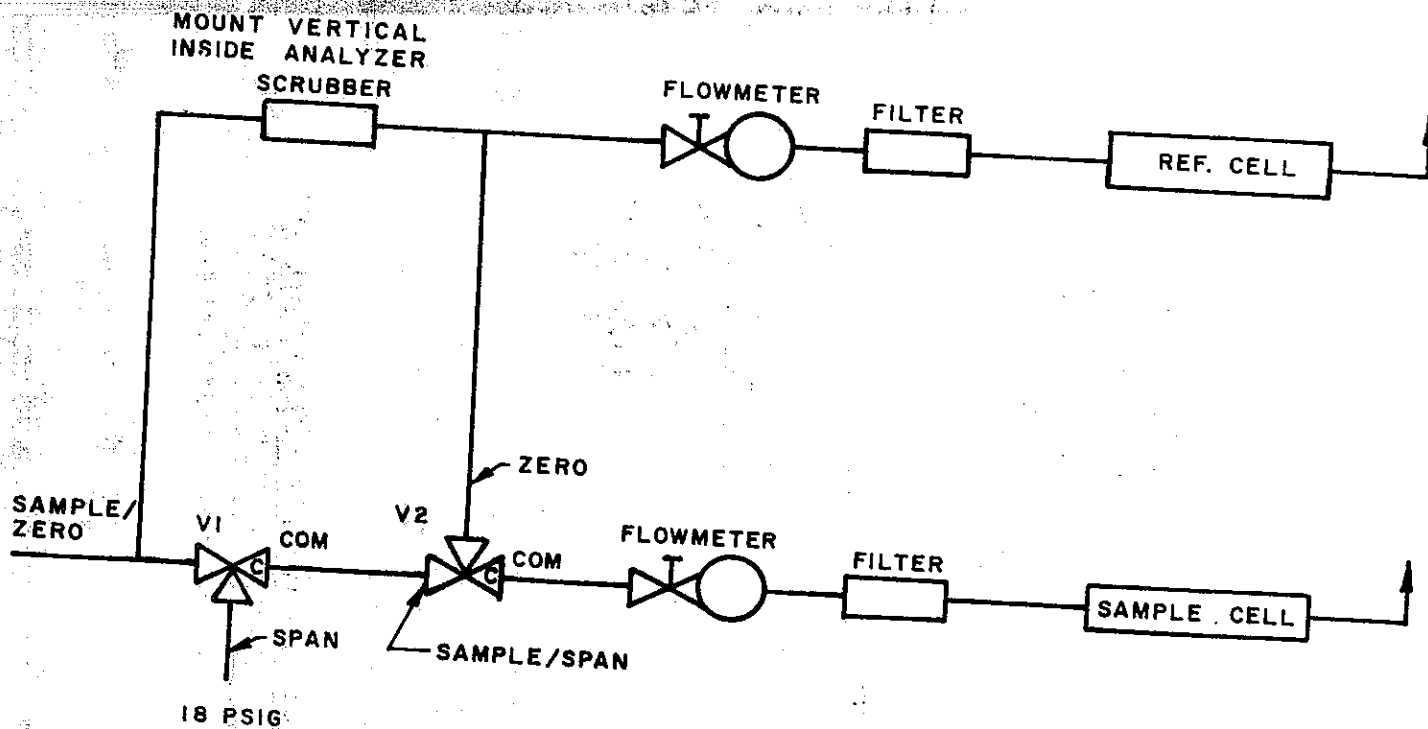
Figure 11

SAMPLE SELECTOR PANEL FOR
MODEL 865 CO-AIR MONITORING
 (FLOWING REFERENCE 'O' PANEL)
 MFG BY BECKMAN INSTRUMENTS INC.

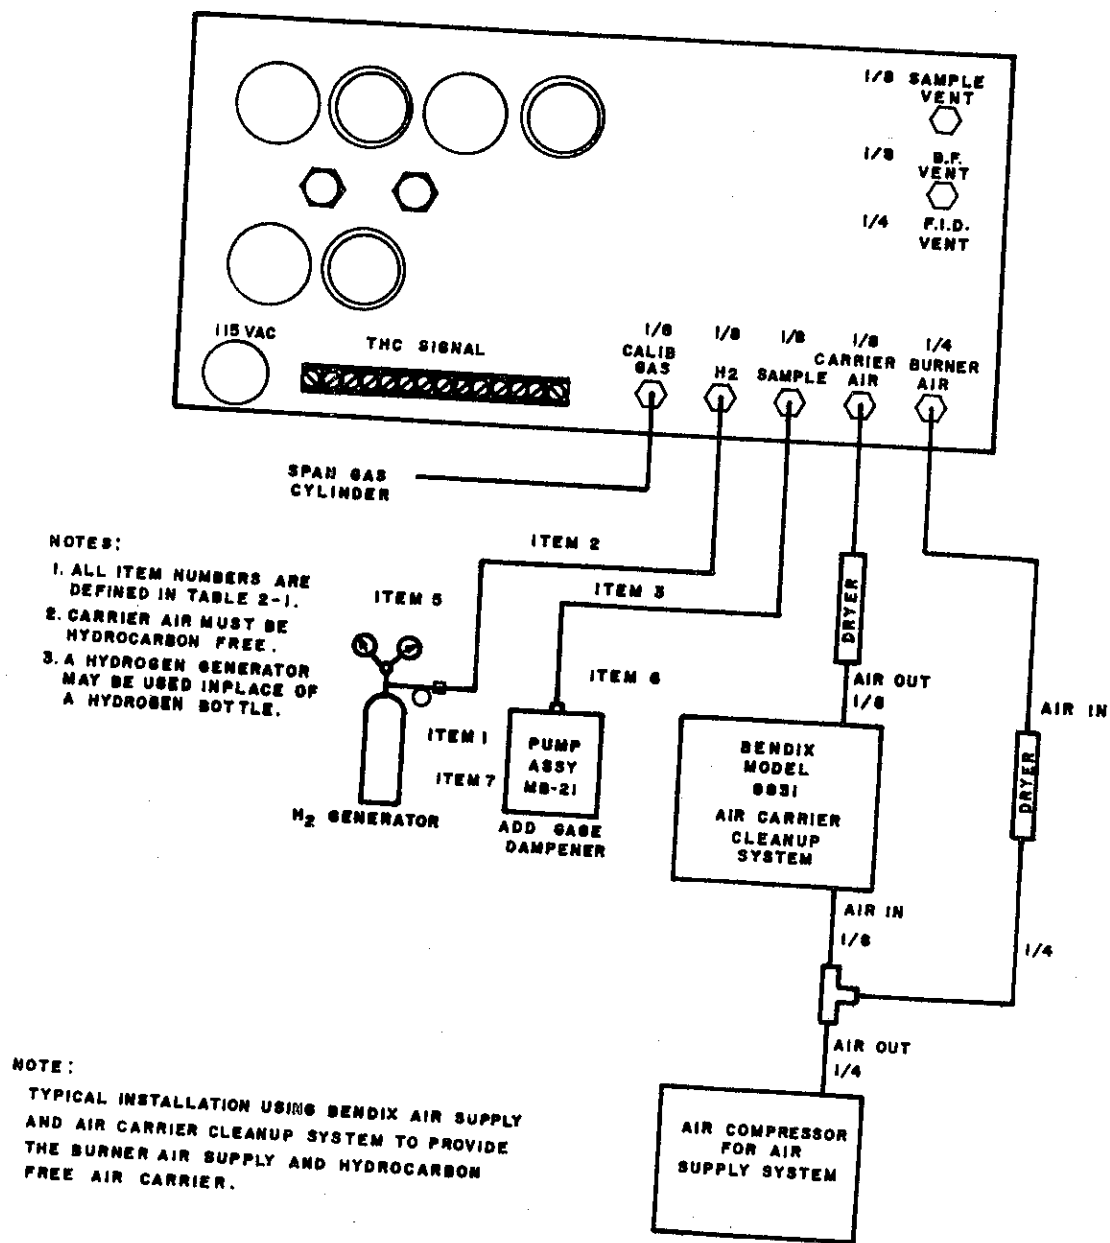
Figure 14

DIAGRAM FOR BENDIX CO MANUAL

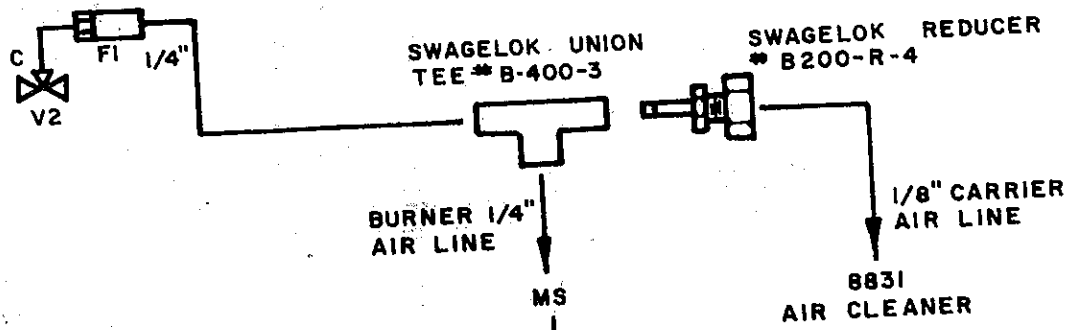
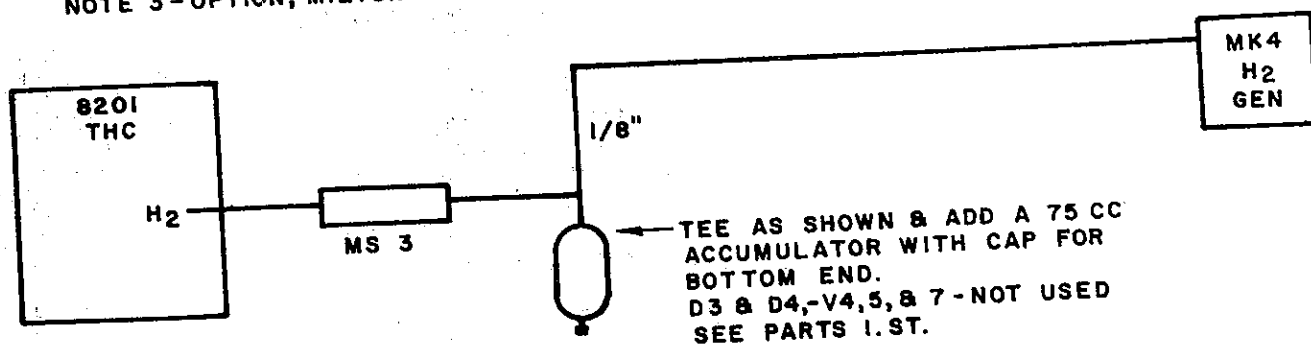
Figure 15

NOTE 1 - REDUCE LINE SIZE AFTER AIR DRIERS.

NOTE 3 - OPTION, MILTON ROY MK4 H₂ GENERATOR.

BENDIX 8201
THC-ANALYZER
AIR SYSTEM

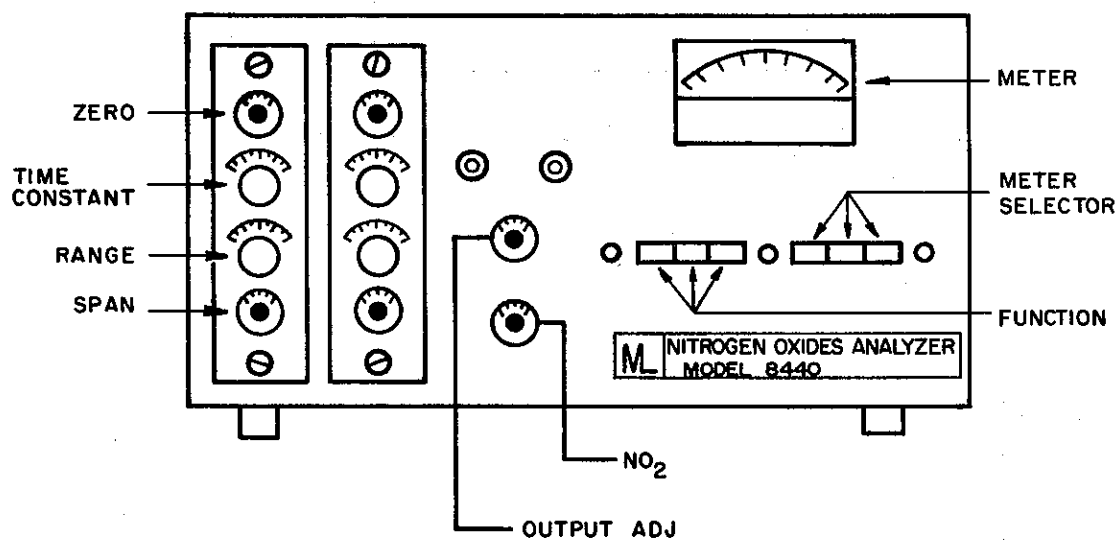
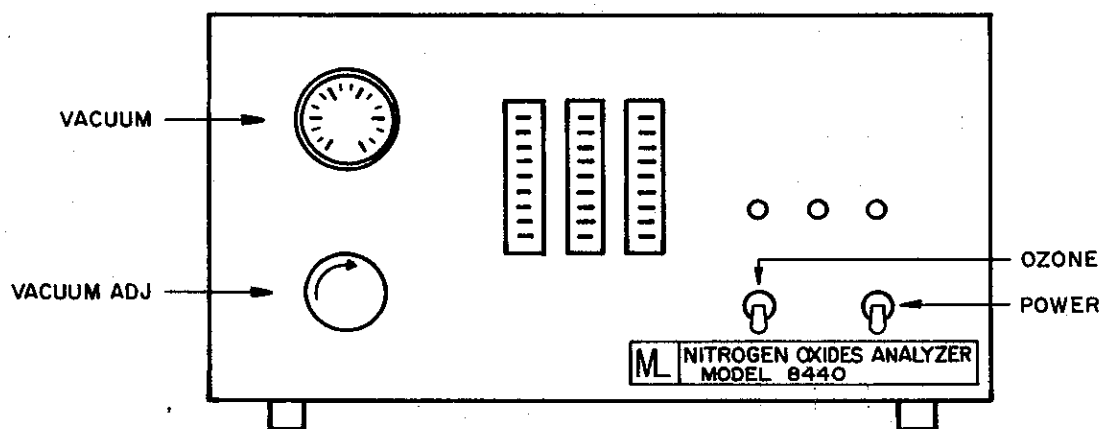
Figure 16

OPERATING CONTROLS
MONITOR LABS MODEL 8440 NO_x ANALYZER

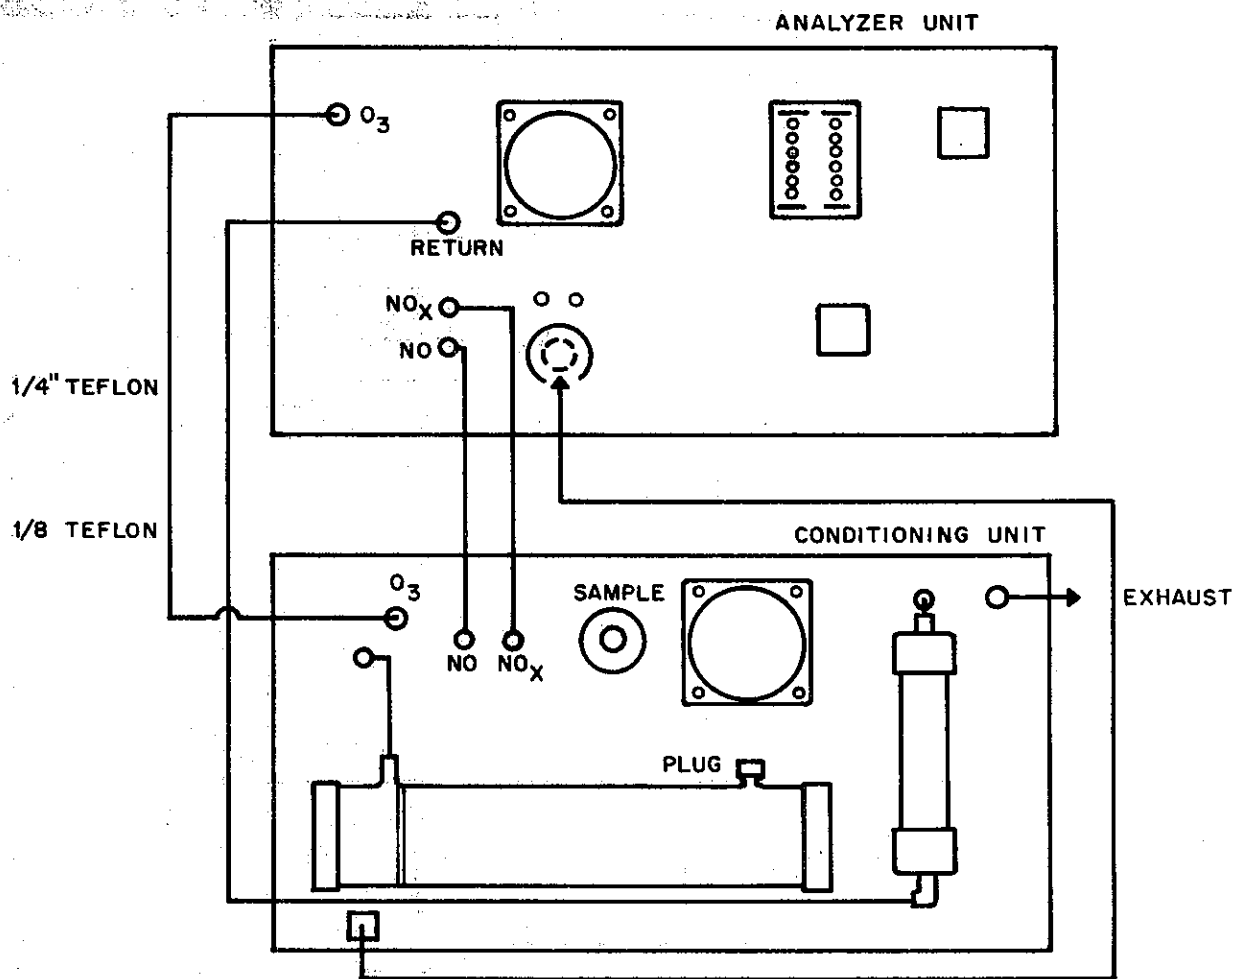
Figure 17

ANALYZER-SAMPLE CONDITIONING INTERFACE
MONITOR LABS MODEL 8440 NO_x ANALYZER

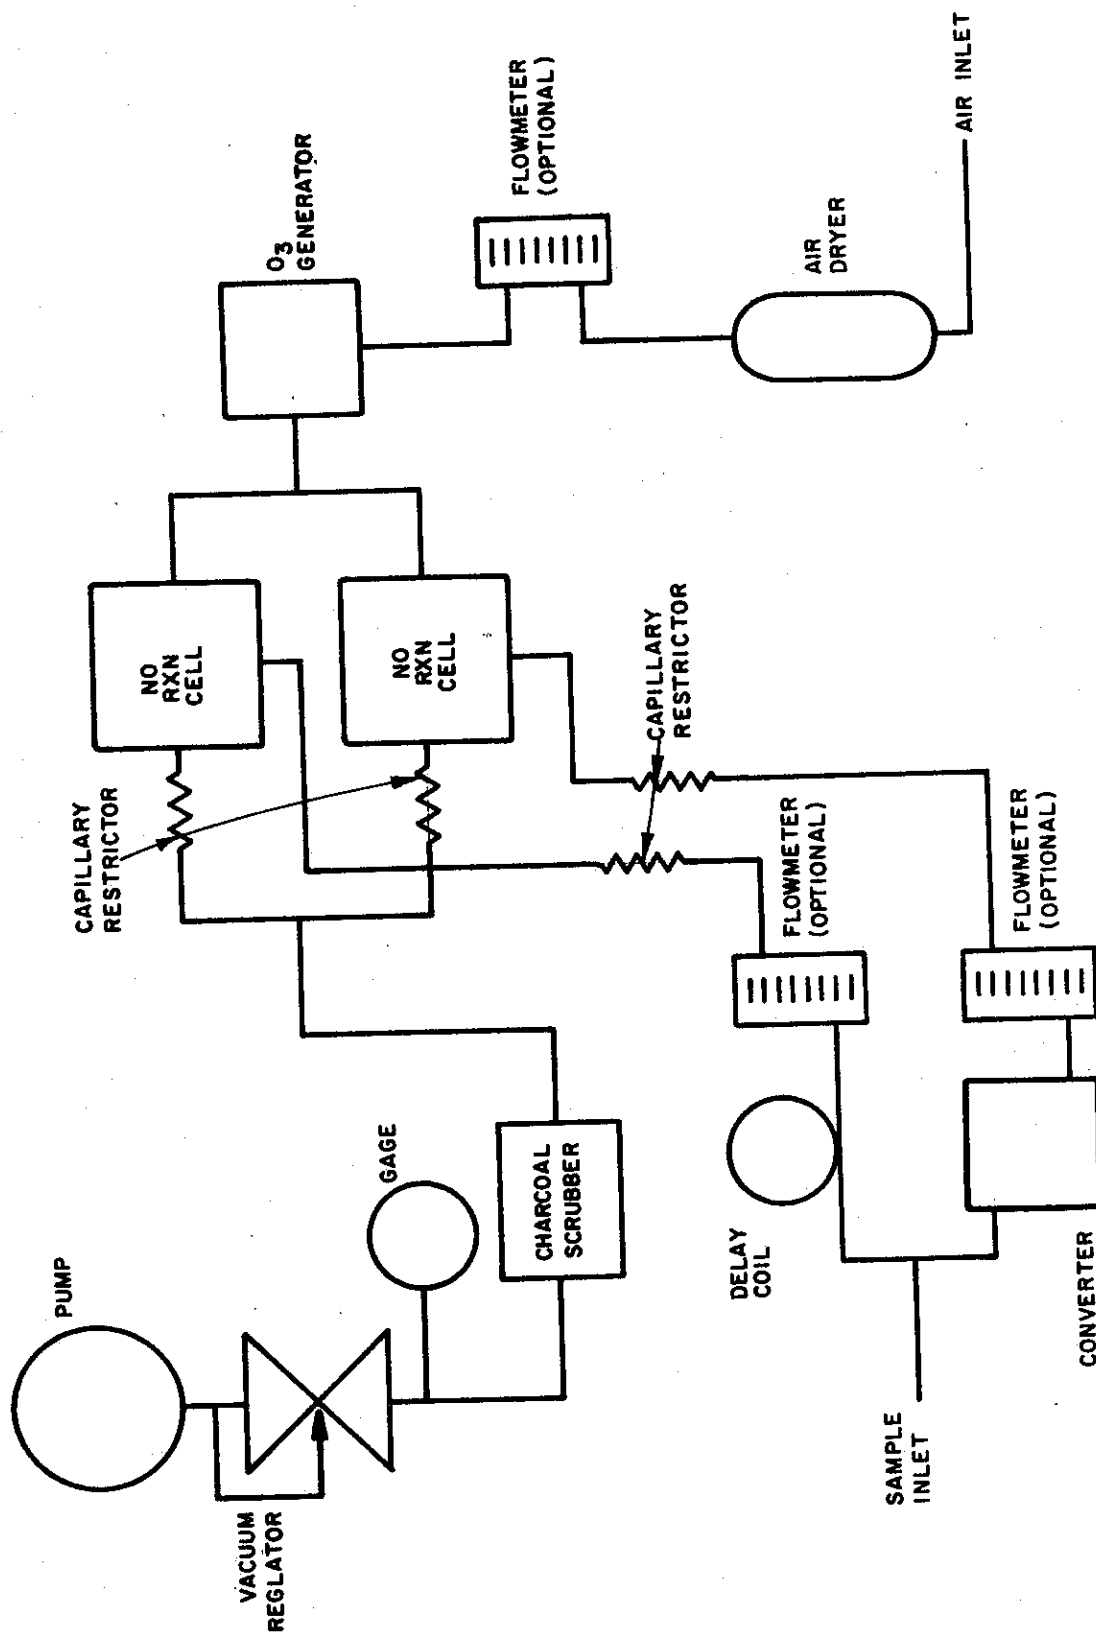
Figure 18

SCHEMATIC FLOW DIAGRAM
MONITOR LABS MODEL 8440 NO_x ANALYZER

The analyzer selected, Monitor Labs Model 8440, operates somewhat differently than other chemiluminescent NO_x analyzers as it has a dual detection system. This replaces cycling the sample through one detector. The operational schematic diagrams are given in Figures 14, 15 and 16 in the Appendix. In addition, it has a signal chopper system to reduce interferences by scanning for the signal only on the frequency generated by the rotating photochoppers. The 8440 works at a vacuum of 18" (45.7 cm) Hg in the reaction cell and controls flows by the critical orifice flow method. It has

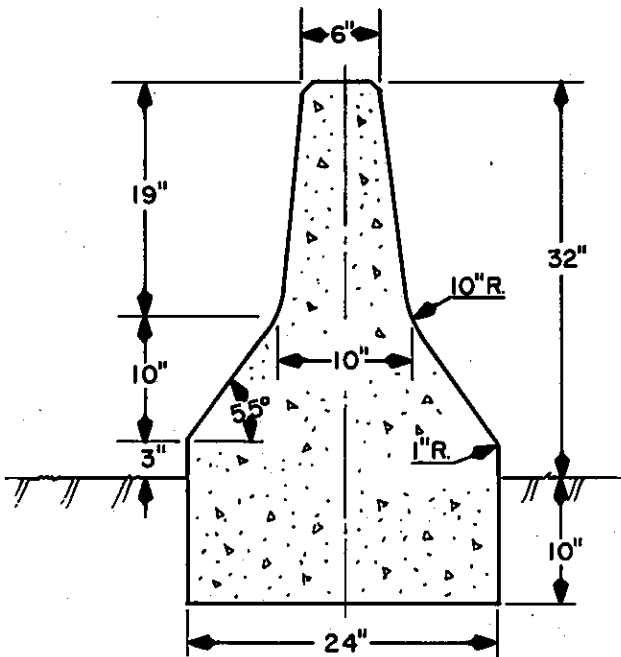
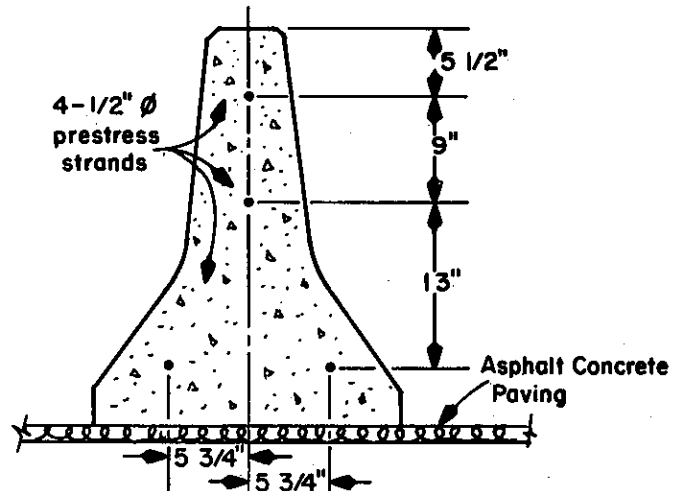
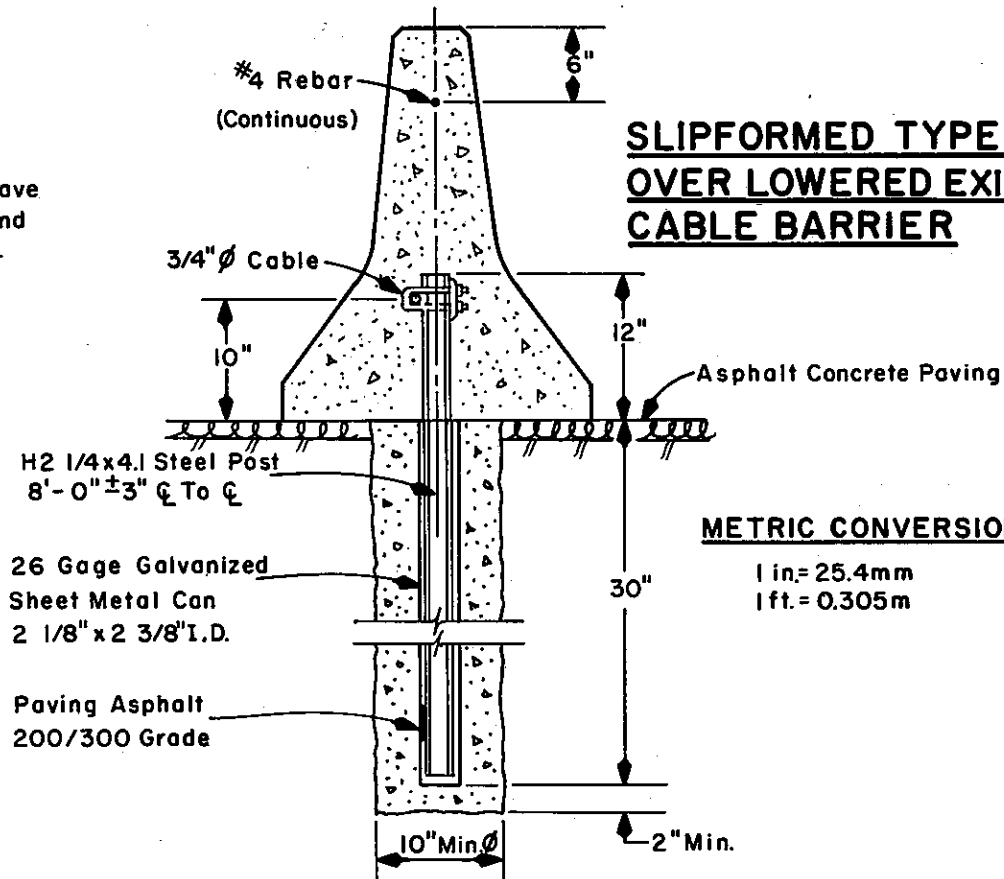
**CONCRETE BARRIER
TYPE 50**

**PRESTRESSED CONCRETE
BARRIER
TYPE 50**

All three designs have the same above ground concrete dimensions.

**SLIPFORMED TYPE 50
OVER LOWERED EXISTING
CABLE BARRIER**

The purpose of this project was to test the structural strength and stability of continuous CMB without a footing. Since 1967 Caltrans has previously evaluated three New Jersey shape CMB designs with different foundation anchorage systems for structural adequacy by conducting crash tests, Figure 1. Other agencies (2,3,4,5) have qualified similar CMB designs.

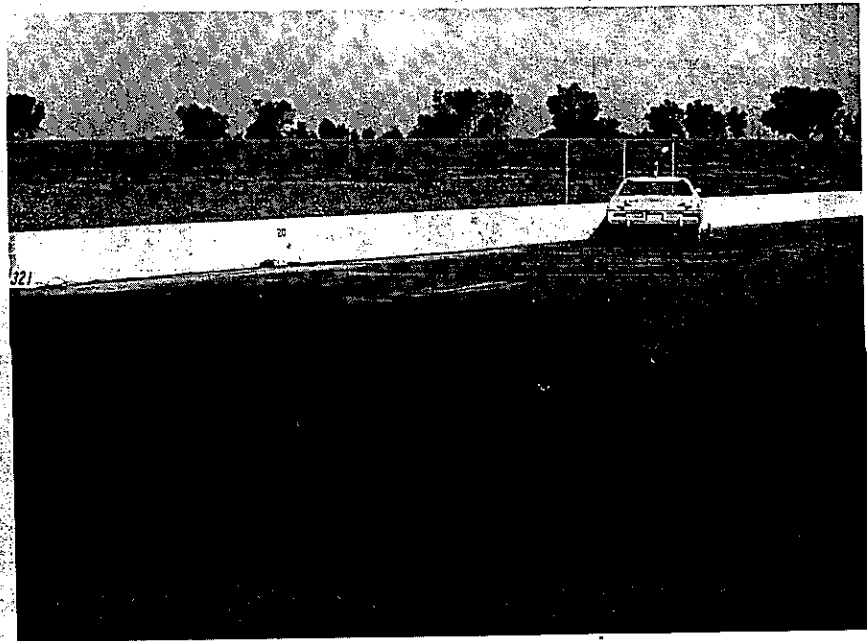
The 120 ft (36.6 m) long test barrier was cast-in-place without a footing on top of a 2 1/2 inch (64 mm) thick asphalt concrete surface, Figure 4.

Figure 4, Test Barrier

The barrier contained two continuous longitudinal No. 4 (12.7 mm) steel reinforcing bars (Grade 40) placed at 6 and 12 inches (152 and 305 mm) down from the top of the barrier.

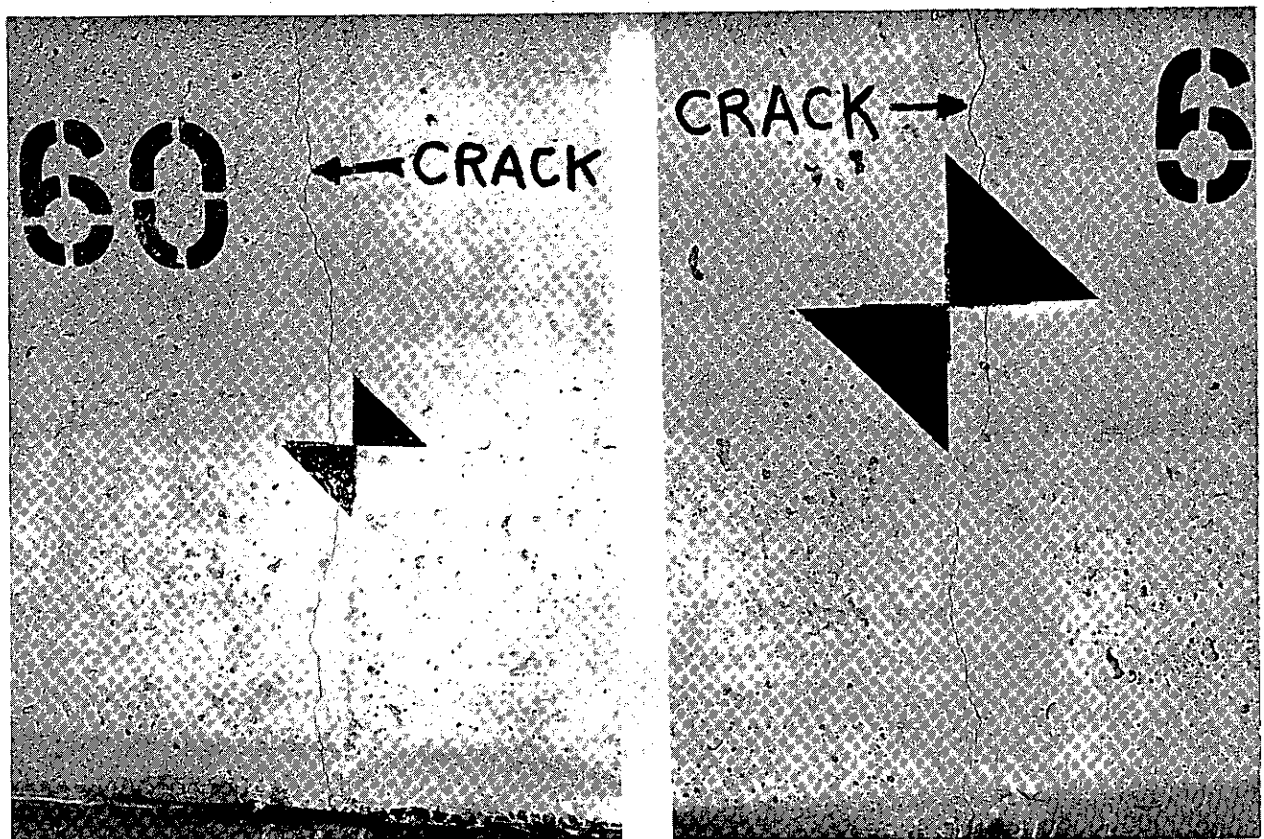
There were no construction or contraction joints in the test barrier section, however, random shrinkage cracks appeared at 26.3, 37, 60, 75.4, and 90 feet (8.0, 11.3, 18.3, 23.0, and 27.4 m) from the upstream end on both sides of the barrier. A typical shrinkage crack is shown in Figure 5.

Figure 5, Shrinkage Crack at Middle of Test Barrier, Sta. 60+00

Impact occurred at a shrinkage crack located in the middle of the barrier at 60 feet (18 m). There was no apparent change in the width of this crack after the test. There was also no change in the size of the other shrinkage cracks as a result of impact.

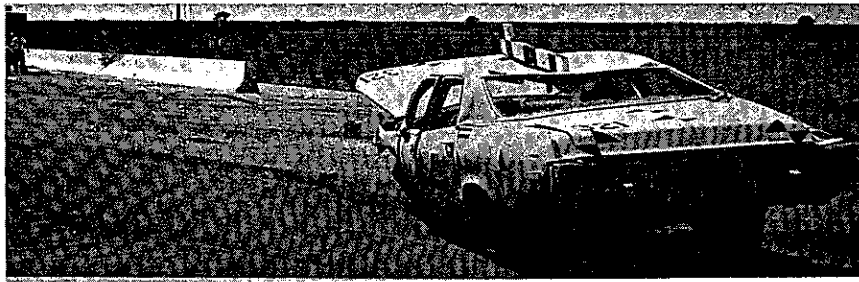
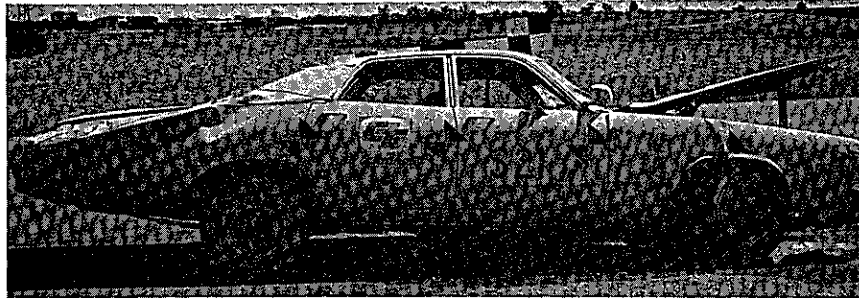
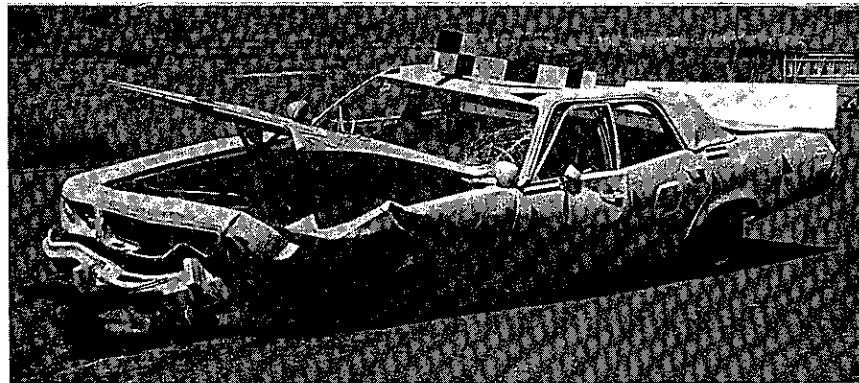
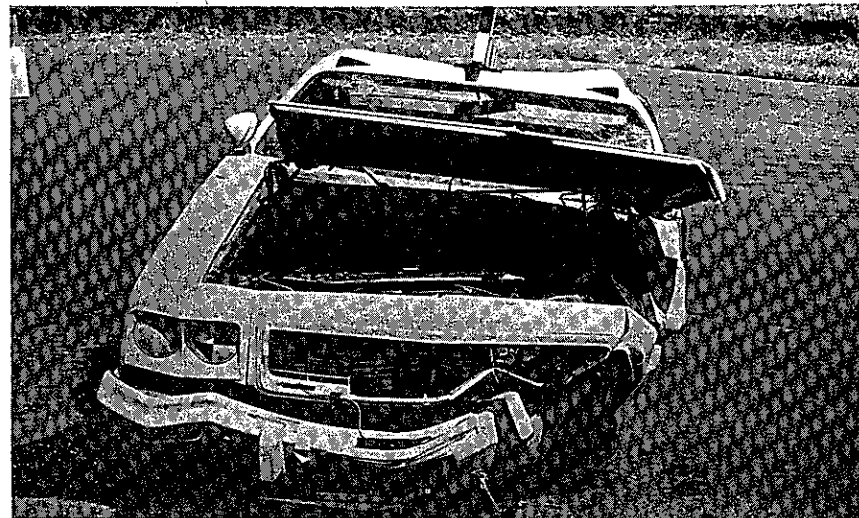
Vehicle Damage - The test vehicle was severely damaged from the barrier impact and the resulting vehicle rollover, Figure 7. The left front quarter panel was crushed back under the vehicle. The floor of the vehicle in the vicinity of the brake pedal was slightly pushed up into the passenger compartment; however, there was no intrusion of vehicle or barrier components. Damage resulting from the vehicle rollover included crushing in of the top of the vehicle about 6 inches (152 mm), broken front and back windshield glass, dents along both sides and on top of the trunk area of the vehicle, and ejection of the vehicle's battery. The battery was found about 60 feet (18 m) away from the end of the barrier and about 11 feet (3.4 m) in front of it. Assessment of vehicle damage according to the Traffic Accident Scale (TAD)(7) and Vehicle Damage Index (VDI)(8) was as follows:

TAD: LFQ-5, LD-3, L&T-5
VDI: 11LFEW5, 00TYG03

Figure 7, Vehicle Damage

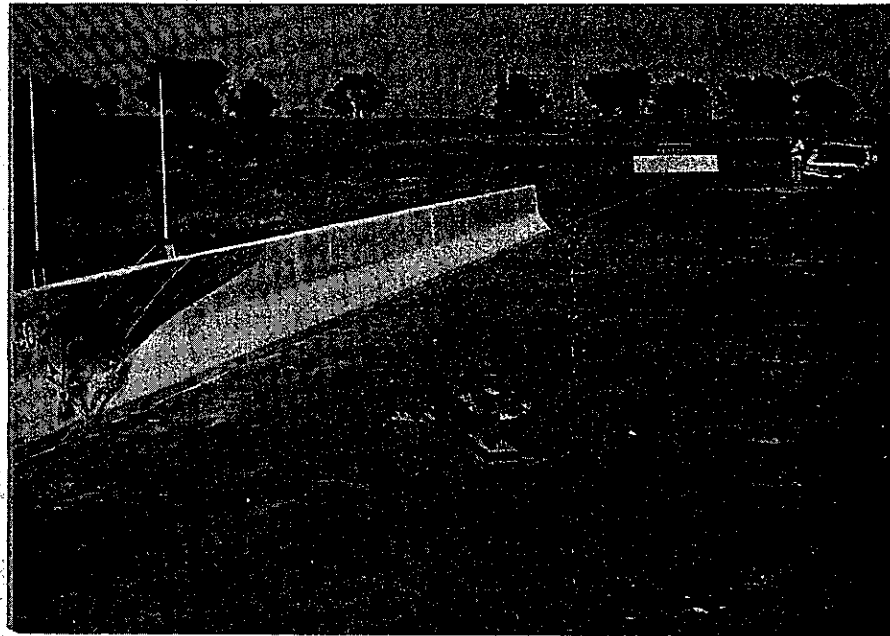
Vehicle Trajectory Hazard - The final resting position of the test vehicle after impact is shown on the Data Summary sheet, Figure 8, in the Test Results section of the report and in Figure 9 below.

Figure 9, Vehicle Position After Impact

The postcrash trajectory of the vehicle probably would have interfered with the flow of adjacent traffic. The maximum rebound distance for the vehicle was 23 feet (7.0 m) from the impact side of the barrier. Assuming an 8 foot (2.4 m) shoulder width next to the CMB and 12 foot (3.7 m) traffic lanes, the test vehicle would have obstructed about 1 1/3 lanes of traffic. The vehicle exited the barrier at about 7 degrees (0.12 rad) at a speed of about 45 mph (20 m/s) in an uncontrolled manner. During the subsequent vehicle rollover, the vehicle's

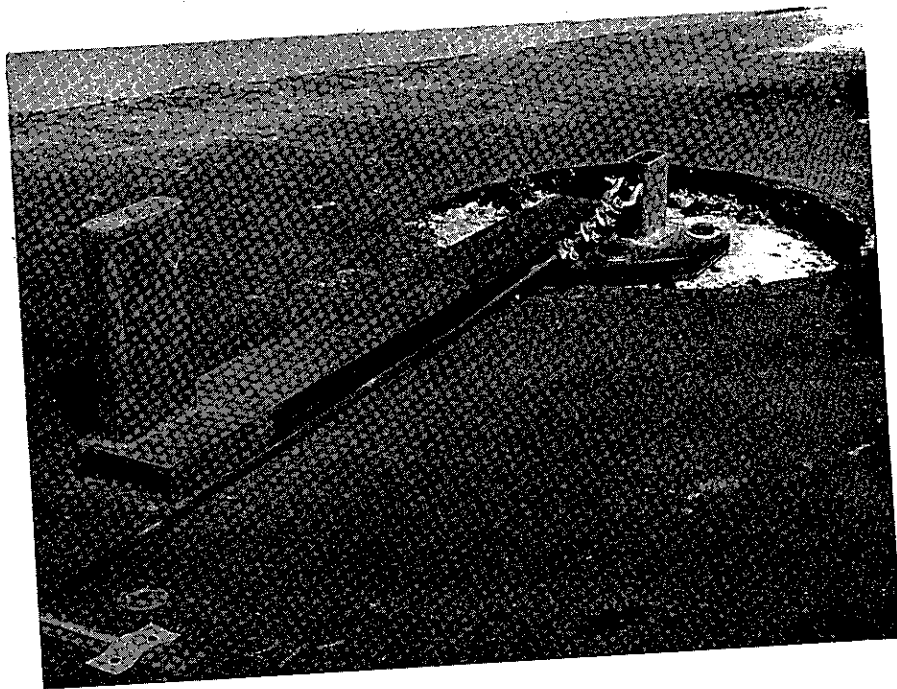
Figure 2A, Steel Knockoff Bracket

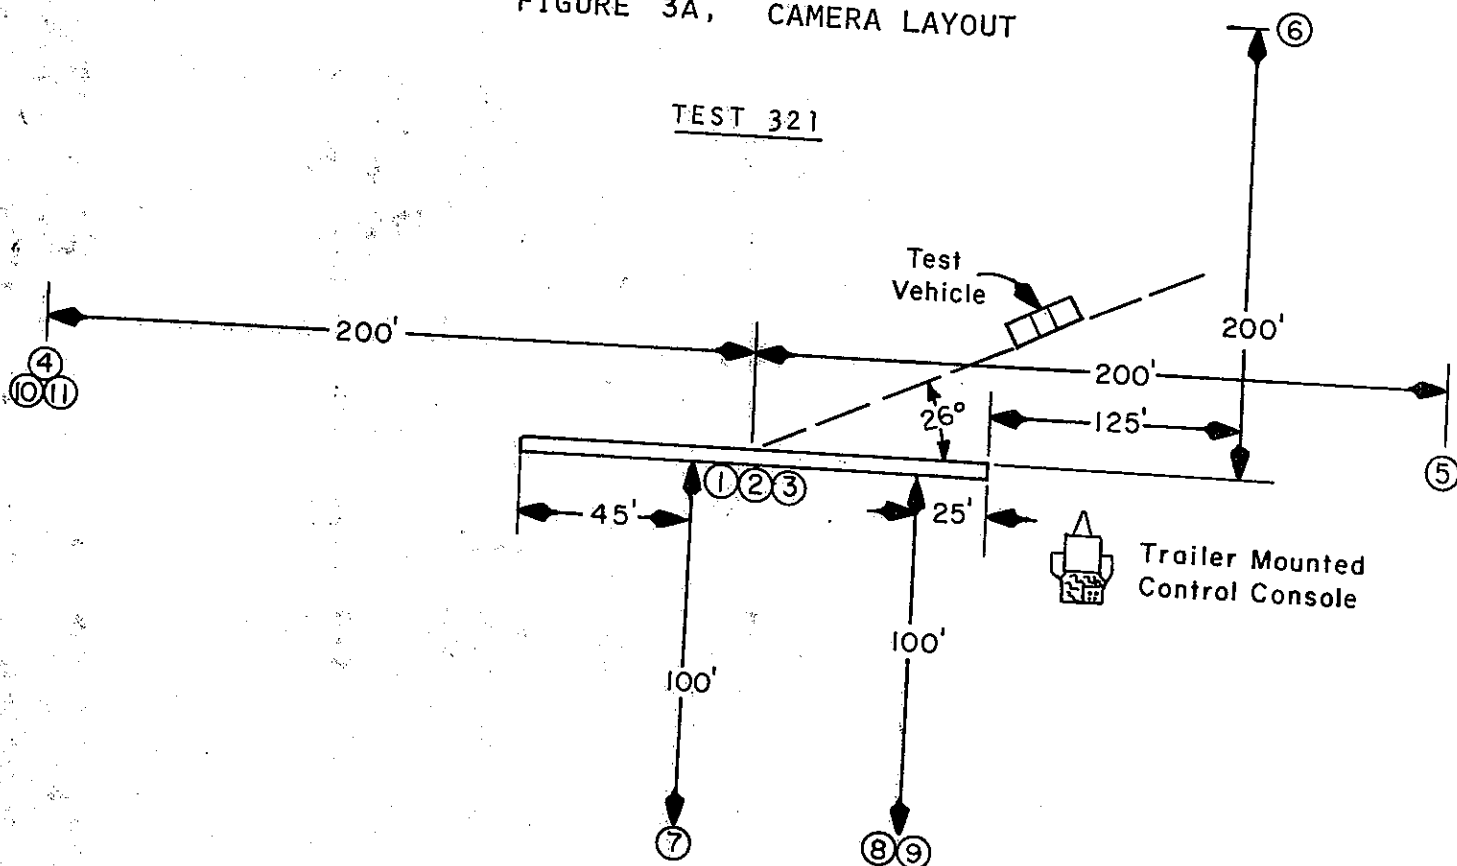
FIGURE 3A, CAMERA LAYOUT

- ①②③ Photo-Sonics Model 16mm-1B, 13mm lens, (275-350) fps²; mounted on 31 ft. tower.
- ④⑤⑥ Photo-Sonics Model 16mm-1B, 4" lens, (300-350) fps.
- ⑦ Redlake Locam 16mm, 12/120mm lens, 500 fps
- ⑧ Photo-Sonics Model 16mm-1B, 2" lens, 350 fps, pan camera
- ⑨ Bolex, 1" lens, 24 fps, pan camera
- ⑩ 70mm Hulcher, 12" lens, 20 fps, sequence camera
- ⑪ 35mm Hulcher, 50mm lens, 20 fps, sequence camera

Data film was obtained by using eight high speed Photo-Sonics Model 16mm-1B cameras, 200-400 frames per second (fps) and a high speed Redlake Locam camera, 500 fps. These cameras were located around the barriers as shown in Figure 3A, Camera Layout. All cameras were electrically actuated from a central control console, Figure 3A.

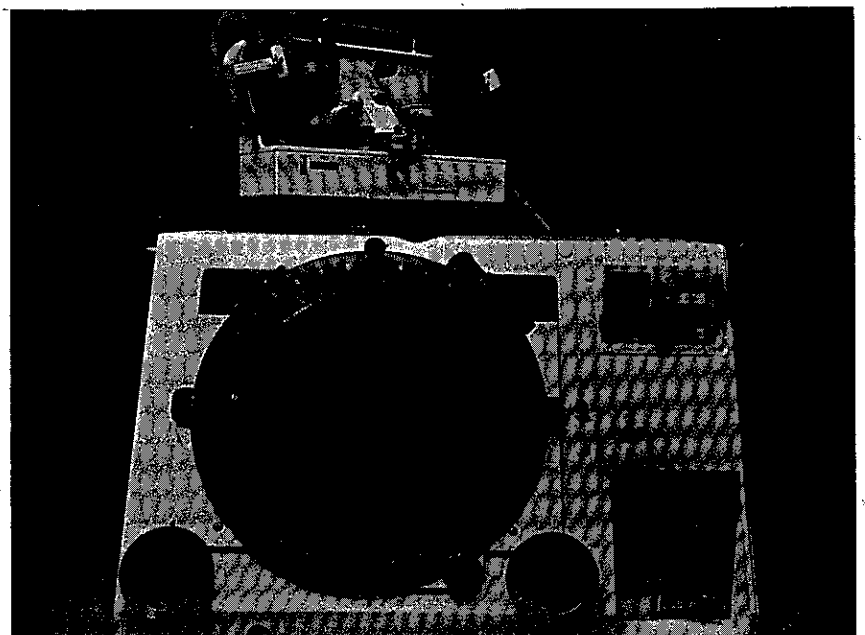
All cameras were equipped with timing light generators which exposed reddish timing pips on the film at a rate of 1000 per second. The pips were used to determine camera frame rates and to establish time-sequence relationships. Additional coverage of the impacts was obtained by a 70mm Hulcher sequence camera and a 35mm Hulcher sequence camera (both operating at 20 frames per second). Documentary coverage of the tests consisted of normal speed movies and still photographs taken before, during, and after each impact. Data from the high speed movies was reduced on a Vanguard Motion Analyzer, Figure 4A.

Figure 4A, Vanguard Motion Analyzer

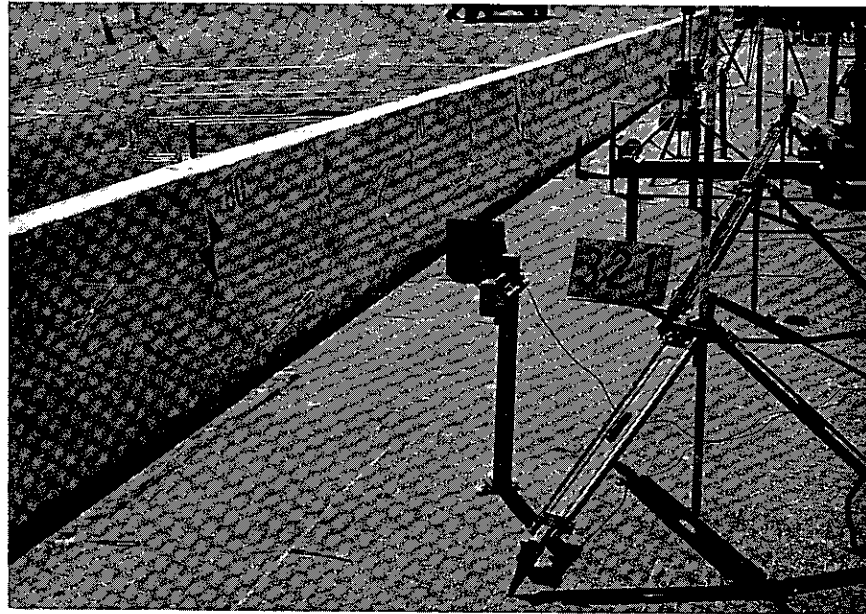
Dynamic barrier deflection was monitored during the test by four Houston deflection potentiometers placed behind the barrier, Figure 5A.

Figure 5A, Deflection Potentiometers
Mounted 4 Feet (1.2 m) Behind Base
of Barrier
